FEEDWATER CAPACITY UPGRADE

INTRODUCTION

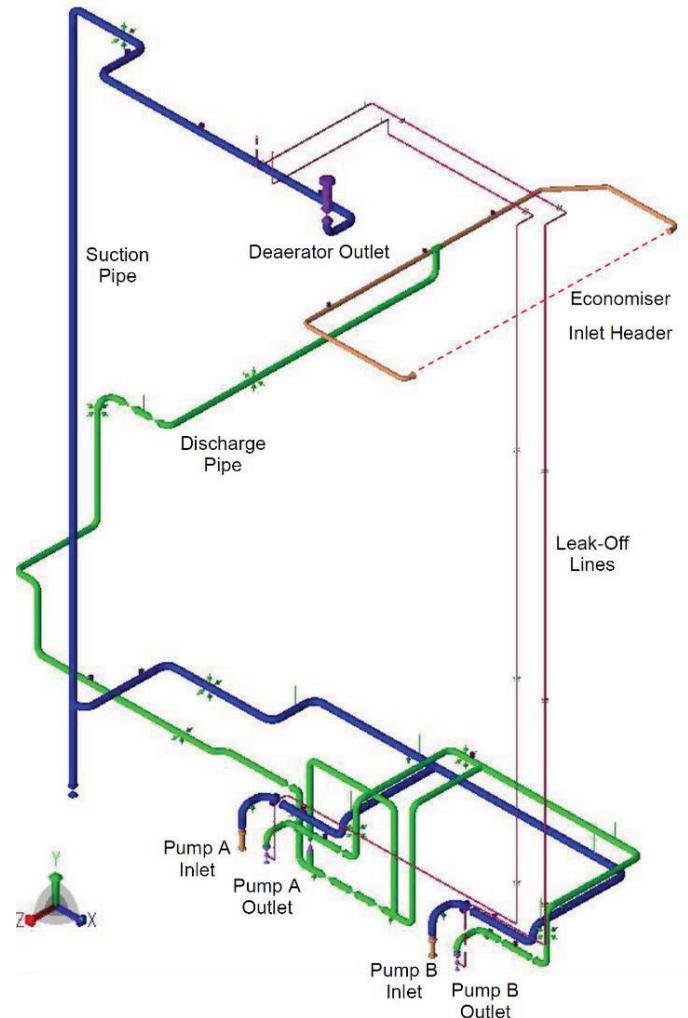
FIGURE 1: FEEDWATER SYSTEM PIPING ARRANGEMENT.

A pump protection valve, located at the outlet of each pump, ensures a minimum flow through the pumps. This theoretically protects the pumps against overheating and cavitation. If the flow through the pumps fall below a certain level, the bypass system opens and water flow via the leak-off lines back to the feedwater tank. After the Schroedahl valve the water flow to two feedwater control valves. After the feedwater control valves the feedwater flows to the bottom inlet header of the economiser of CRF #2, situated 24 m above ground level. An accurate model of the feedwater system piping is shown in Figure 1.

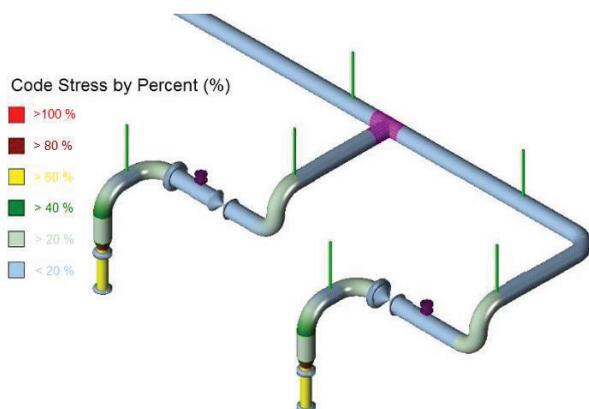
FIGURE 2: STATIC STRESS MODEL AT THE PUMPS.

During the analysis, some significant anomalies were identified regarding the supporting of these piping systems. The analysis considered the existing systems, which differed from the original design intention, insofar as could be established. These anomalies were generally seen to be as a result of degradation of the supporting over many years, and undocumented repairs and/or modifications made over this same period.

The static analysis results also indicated that the piping systems were generally acceptable for steady state operation, this can

been interpreted from Figure 2, on the other hand better thermal expansion control was also needed. During the modal analysis these systems were found to be dynamically unstable.

1. The systems were acceptable for steady state operation, but would require slight supporting philosophy modification to allow for better thermal expansion control.
2. The systems were dynamically unstable and would require extensive supporting philosophy modifications to ensure that the resonant response of the systems were averted under any form of dynamic loading.
3. Dynamic analysis of any possible water hammer event should be undertaken.
4. The pipe routings were acceptable.
5. The process and operating philosophies were to be redesigned, to eliminate the risk experiencing future

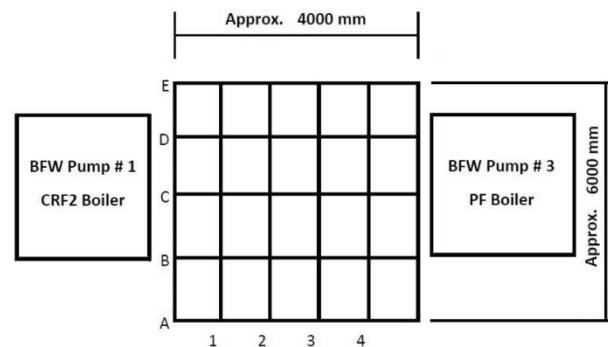
FIGURE 3: STATIC STRESS MODEL AT THE PUMPS.

During normal operation of the feed water system, some vibration characteristics were identified (or assumed) to be emanating from the floor structure between the CRF2 and PF boiler feed pumps. In discussion with the client's condition monitoring technicians, a so-called "weak point" was identified at this location. Site inspection indicated that this point displayed greater vibration characteristics than the surrounding areas. Vibration measurements were recorded along a grid pattern in this area, to establish if any possible dynamic structure instability contributed to the adverse vibration conditions experienced. Figure 3 below, gives indication to size of the area measured.

During this exercise, no abnormal vibration conditions were evident, resulting in measured data representing a steady state of operation. However, as the systems were operating in a steady state during the test and it was expected that amplitudes would increase during any dynamic events.

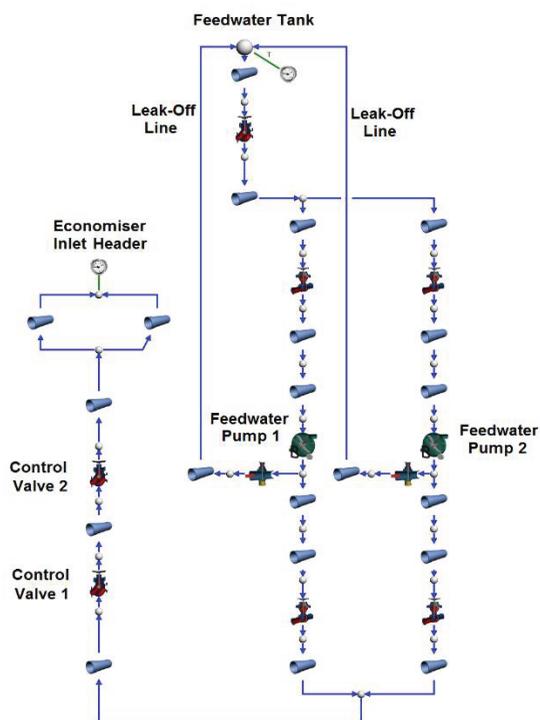
FIGURE 4: L SIMULATION MODEL FOR THERMAL-HYDRAULIC ANALYSIS.

A Flownex software model, Figure 4, was developed to assess the overall performance of the systems under steady state and upset condition operation. The control philosophy of the system was assessed to establish if any flow related condition is contributing to the vibrations experienced.

With the operating temperature at 152 °C, equating to a saturation pressure of 502 kPa. The flow velocities for each pipe section was correspondingly calculated at the average feedwater flowrate. The calculated flow velocities on the suction side was slightly above the allowable value stated in Babcock procedures and technical manuals, but did not pose a risk in terms of vibration excitation.

No unstable behaviour was noted during steady state operation.

- Sudden valve closure would not pose a risk of feedwater flashing, but would likely lead to a dynamic water hammer incident,
- Any sudden valve closure, followed by a valve opening event (regardless of magnitude) had a strong tendency to cause flashing within pump suction lines, causing flow instabilities on the suction side of the pump. Once flow was unstable, this flashing mechanism became self-sustaining. Pump cavitation was also observed during this event,
- Any sudden valve opening event, would lead to feedwater flashing over within individual pump suction lines, which quickly dissipates,

The control philosophy at the time, was scripted in such a fashion as to promote flow instabilities during control valve closure events.
