FATIGUE ASSESSMENT OF A BOILER STEAM DRUM

INTRODUCTION

This work addresses fatigue assessment of a 200MW boiler steam drum. It was done in the context of a life extension study to determine if the boiler could be used until 2035. Given the high cost of replacing the steam drum, it is very important to understand its structural integrity. The main concern with regard to drum integrity is widespread fatigue cracking of large nozzle welds or seam welds. Fatigue in the steam drum is primarily caused by the combined action of pressure and temperature cycling.

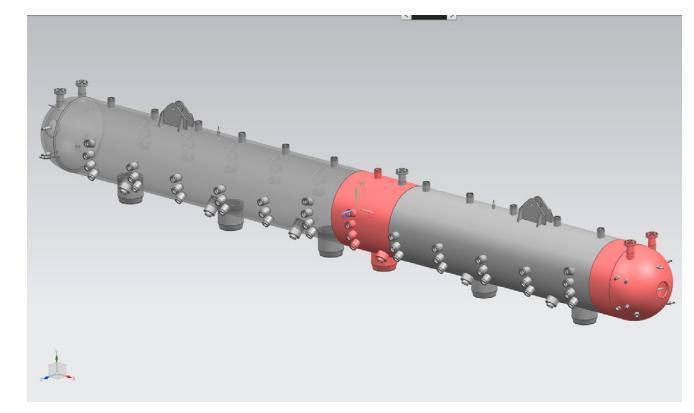
Figure 1: Sections of the steam drum chosen for FE analysis (shown highlighted).

Figure 1 shows an isometric view of the drum. It consists of a seam-welded cylindrical shell with spherical ends and is approximately 19m in overall length. It is supplied with water from the economiser and then supplies water to the furnace walls via the large downcomer nozzles at the bottom. Saturated water and steam are returned to the drum through a multitude of riser nozzles. Drum internals (cyclones and scrubbers) then separate the steam from water and steam exits at the saturated steam nozzles at the top of the drum, from where it travels to the superheaters.

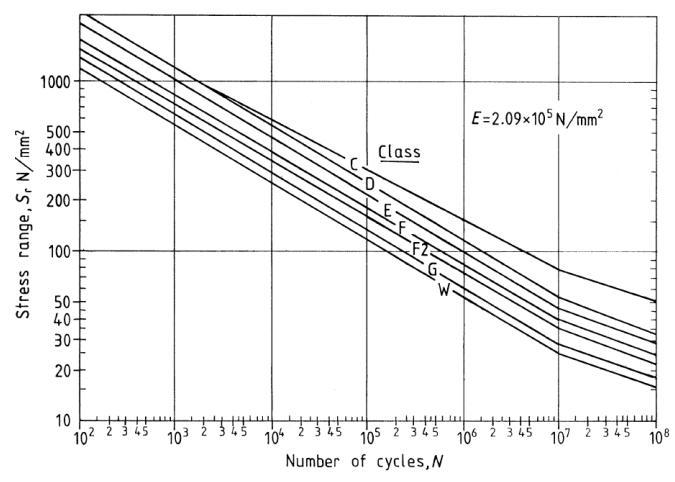
Figure 2: PD5500 S-N Curves

In keeping with a conservative assessment, fatigue damage calculations were based on design S-N data. S-N curves in PD5500 are two standard deviations below the mean, corresponding to 97.7% probability of survival. Several curves are given: one for unwelded material and then curves which correspond to various component classes. Each feature was therefore categorized and its stress ranges were evaluated against the appropriate curve.

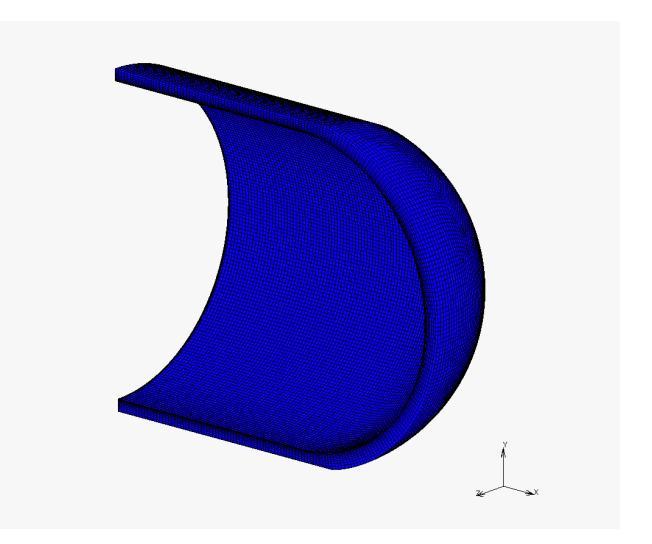
Figure 3: Boundary conditions on the clean drum model

The first analysis considered pressure and thermal cycling of a "clean" drum—one without any stress raisers (see Figure 3). The reasoning was that the damage in the real drum will always be worse than the damage estimated for a clean drum. Therefore, if evaluation of the clean drum yielded unacceptable fatigue damage, then the real drum would definitely be in jeopardy.

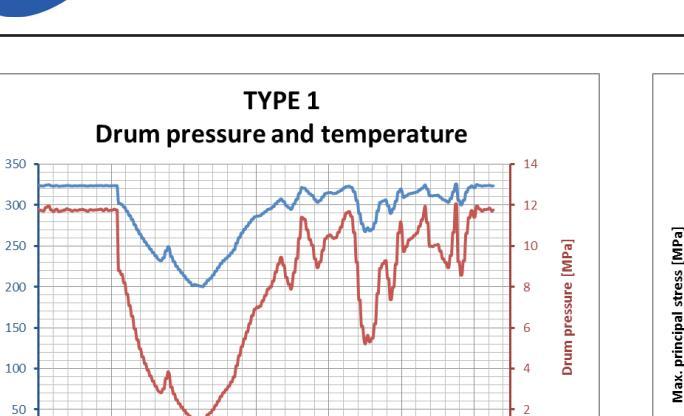
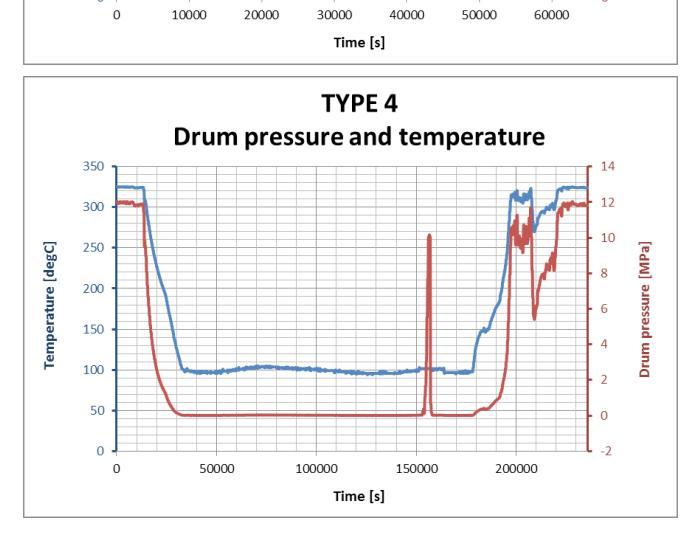
Figure 4: Drum pressure and saturation temperature during type 1 and type 4 cycles.

The finite element model comprised a short section of the main shell together with a drumhead. The stress response was calculated under the action of the 5 operating cycle types (see Figure 4 for the measured operating data^c used in the analysis; data shown only for Type 1 and Type 4 cycles). A linear-elastic material model was used with temperature-dependent physical, mechanical and heat transfer properties. An infinite heat transfer coefficient was assumed on the inner diameter of the drum, which means that the inner surface follows the saturation temperature exactly.

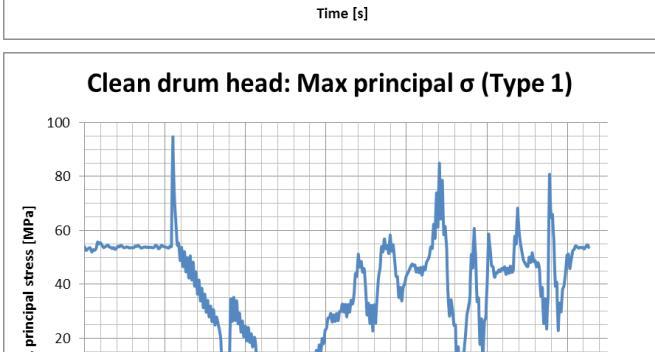
Figure 5: Maximum principle stress histories for clean drum and heads.

The results showed that the main shell is practically unaffected by thermal transients and the associated stresses; fatigue in the main shell is therefore driven by pressure cycles. The drumheads, on the other hand, develop much greater thermal stresses due to their greater thickness.

Figure 5 shows the stresses during a shutdown-start cycle for the main shell and for the drumheads. These stress histories represent the worst cases out of the 5 cycles evaluated for the respective components.

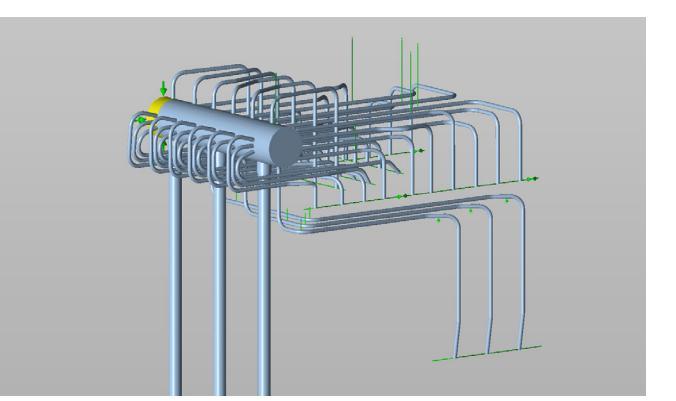
Figure 6: Caesar II model of drum and pipework.

In the second analysis stage, the magnitude of nozzle loads caused by thermal expansion of the boiler and pipework were estimated. This was conducted by means of a pipework model (see Figure 6) incorporating the drum, its slings, the integral pipework, downcomers, and drum and header movements. Nozzle loads were extracted from this model for subsequent use in the detailed finite element model.

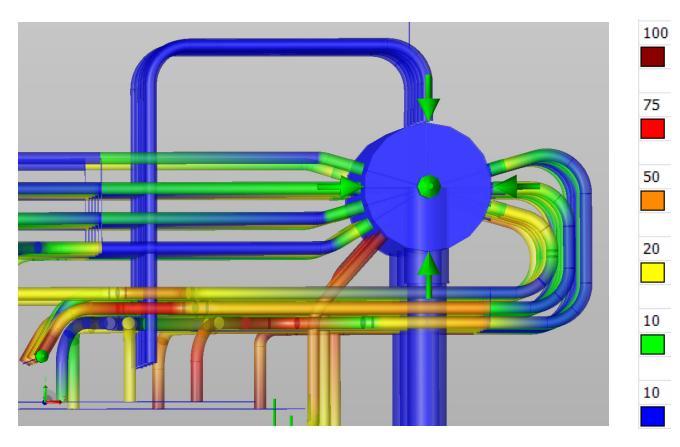
Figure 7: Stress ranges [MPA] in the pipework and nozzles due to thermal expansion.

Figure 7 shows the results obtained. It was found that downcomer nozzle loading is insignificant, resulting in stress ranges of less than 10MPa. However, all other nozzles experience loads which could not be ruled out as insignificant.

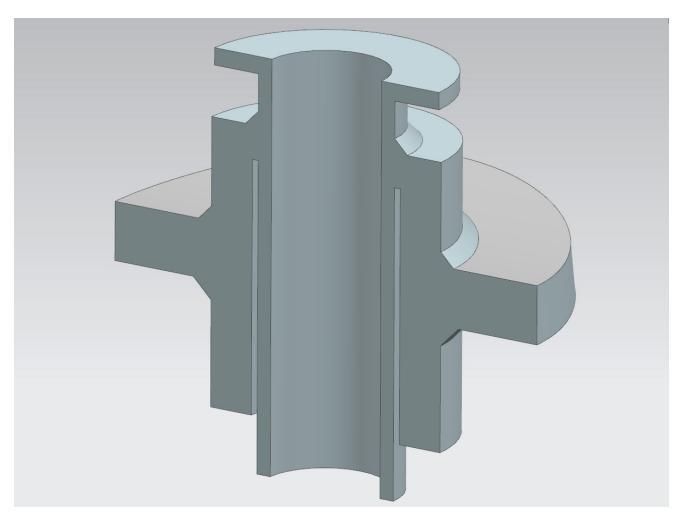
Figure 8: Geometry of economizer feed connection.

As previously noted, the economizer feed connection warrants detailed treatment, since it is the component in the drum that experiences the highest temperature differential. This temperature gradient is localized around the thermal sleeve-to-nozzle weld (see geometry shown in Figure 8).

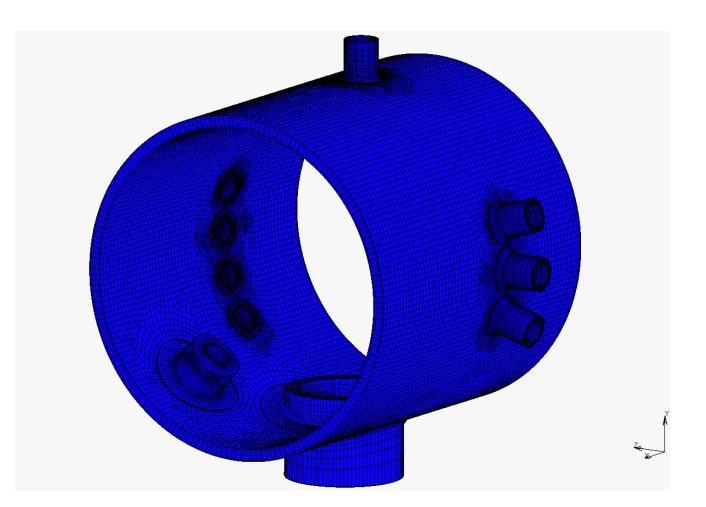
Figure 9: Mesh of the main shell.

Owing to the complexity of the geometry and loading, finite element models were used to calculate the stresses in the drum. Since we were interested in the detailed stress distributions through the thickness, we used solid models. The models comprise of 8-noded, first-order brick elements (see Figure 9 and Figure 10). Since all detail could not be captured in one model, a global-local mapping approach was used from the mesh of the shell to the economiser feed connection mesh.

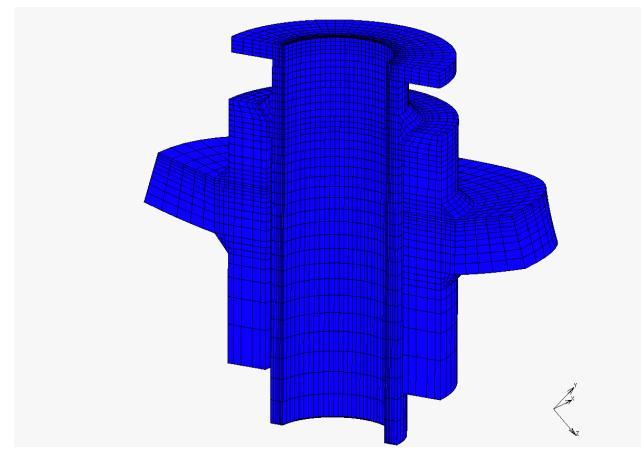
Figure 10: Economiser feed connection mesh.

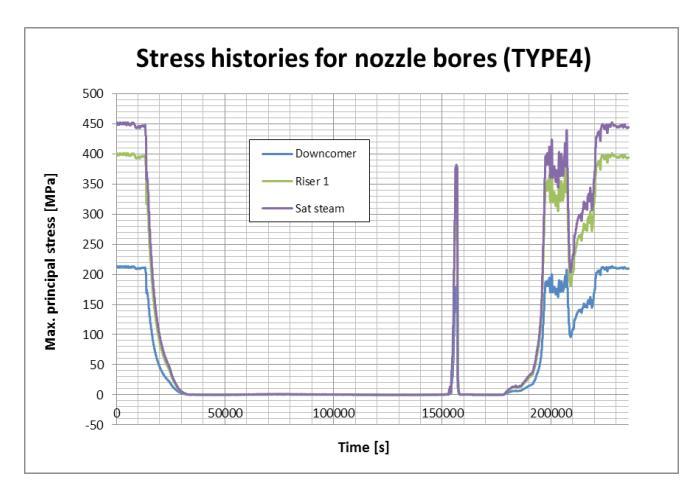
Figure 11: Nozzle bore stress histories.

Figure 11 and Figure 12 show the stresses obtained from the model for various nozzle bores and shell-to-nozzle welds during a Type 4 cycle. In the case of the welds, the principal stress shown was based on linearized stress components. After cycle counting, projected damages at 2035 were calculated:

•	Saturated steam nozzles:	D = 0.32 (32%)
•	Downcomer welds:	D = 0.053 (5.3%).

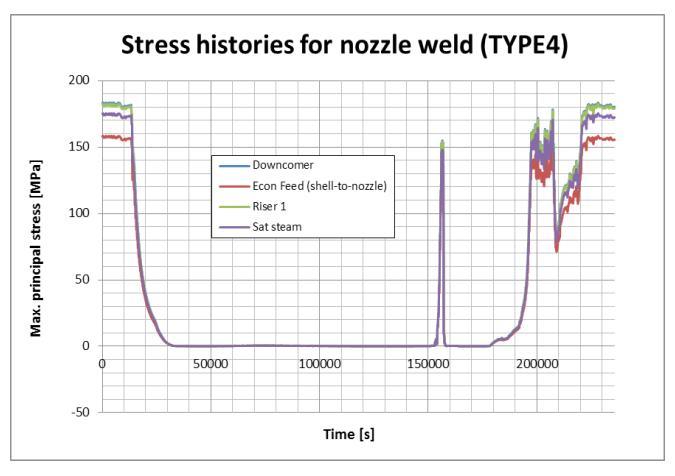
Figure 12: Nozzle weld linearized stress histories.

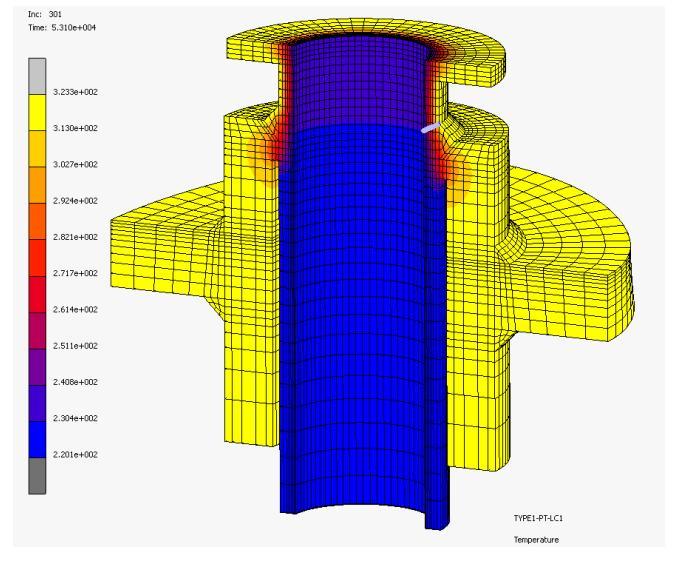
Figure 13: Temperature distribution in economizer feed connection during startup.

From the model results it was seen that a ΔT of approximately 95 °C occurs over the sleeve-to-nozzle weld. The temperature distribution during a start-up moment, where there is a difference of 103 °C between the feedwater and drum temperature, is shown in Figure 13.

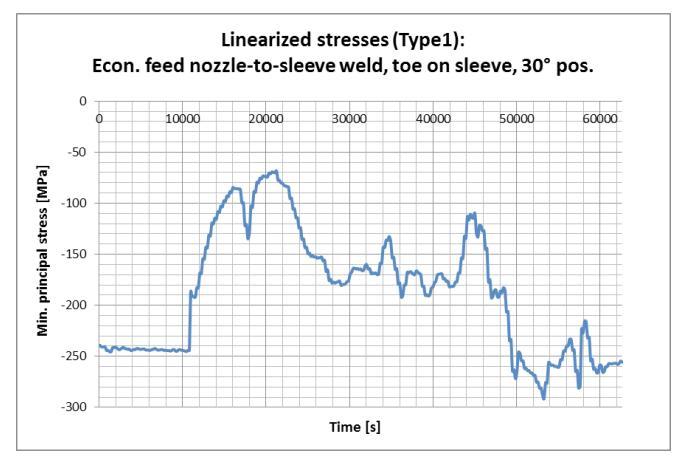
Figure 14: Stress history for the economizer feed nozzle -to-feed weld (type 1).

Figure 14 shows the linearized stress histories obtained after processing the FE model results. It was noted that the nozzle-to-sleeve weld experiences the worst stress ranges. Estimated damage at 2035 amounts to 0.025 (2.5%).

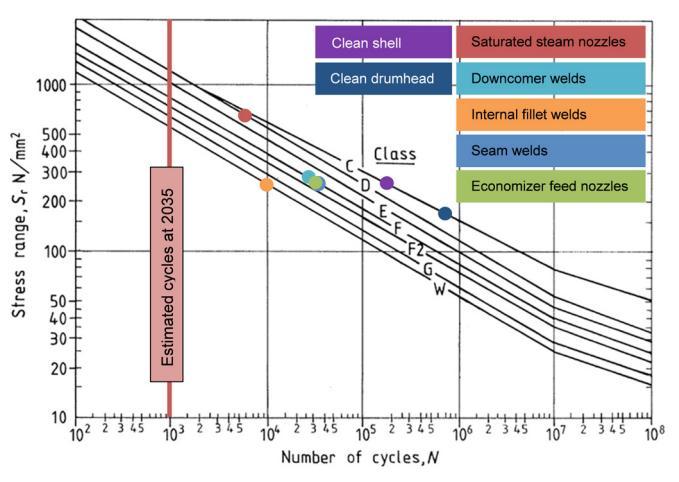
Figure 15: Summary of results on PD5500 S-N curves.

The graph below summarizes the results of the work on the design S-N curves of PD5500. It is estimated that the drum will have seen 984 cycles by 2035. The dots on the graph indicate the stress ranges (fully adjusted for various factors) and associated cycles to failure. It was established that the drum's major features have substantial fatigue life margins.
